# San Fernando, California, Earthquake of February 9, 1971

U.S. DEPARTMENT OF COMMERCE  
National Oceanic and Atmospheric Administration

*Part B. Buildings continued; Soils and Foundations*

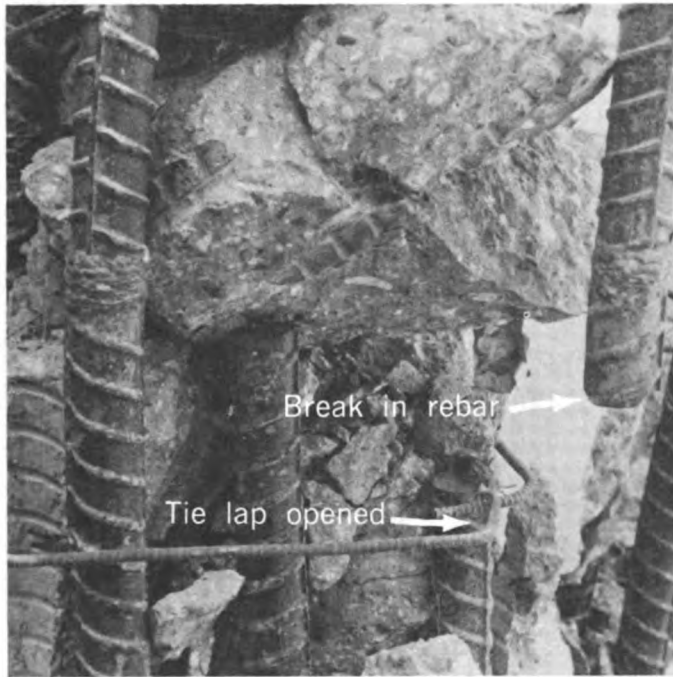
characteristics also were present in the columns with closely spaced spiral reinforcing (figs. 24,E and 25). There was distress in many of the beam-column connections (figs. 26 and 27) where the stirrups or ties did not extend through the joints. Failure occurred in the corner tied columns (figs. 24,E, 28, and 29). Interestingly, the vertical and lateral loads, which caused the collapse of these corner columns, were transferred to the adjacent exterior columns through the cantilever action of the walls above the column (figs. 30 and 31).

Figure 29.—Olive View Hospital, medical treatment and care unit. Fracture detail of reinforcing bars near a full-penetration butt weld for column in figure 28. Note opening of column tie laps at corner.

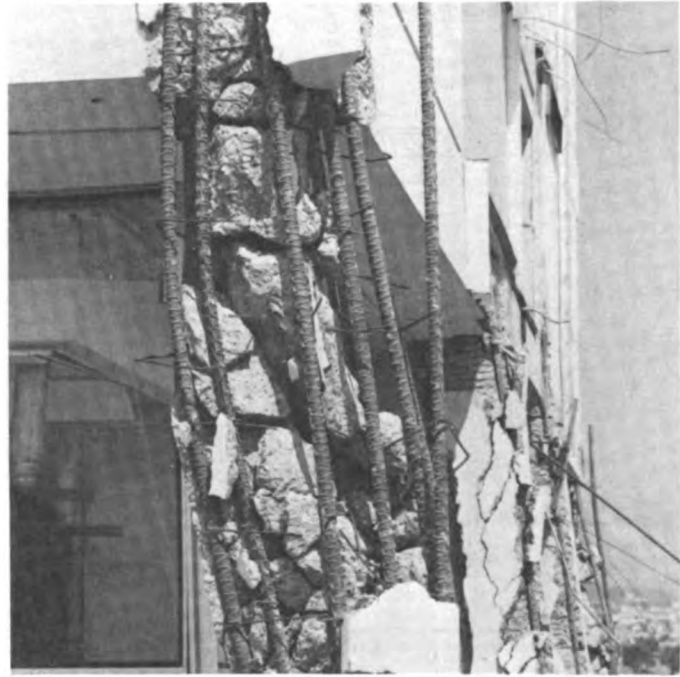
Figure 30.—Olive View Hospital, medical treatment and care unit. View at end of building wing at first-floor level. The wall above probably has carried collapsed corner column load to interior column line. Stair tower is at right of photo.

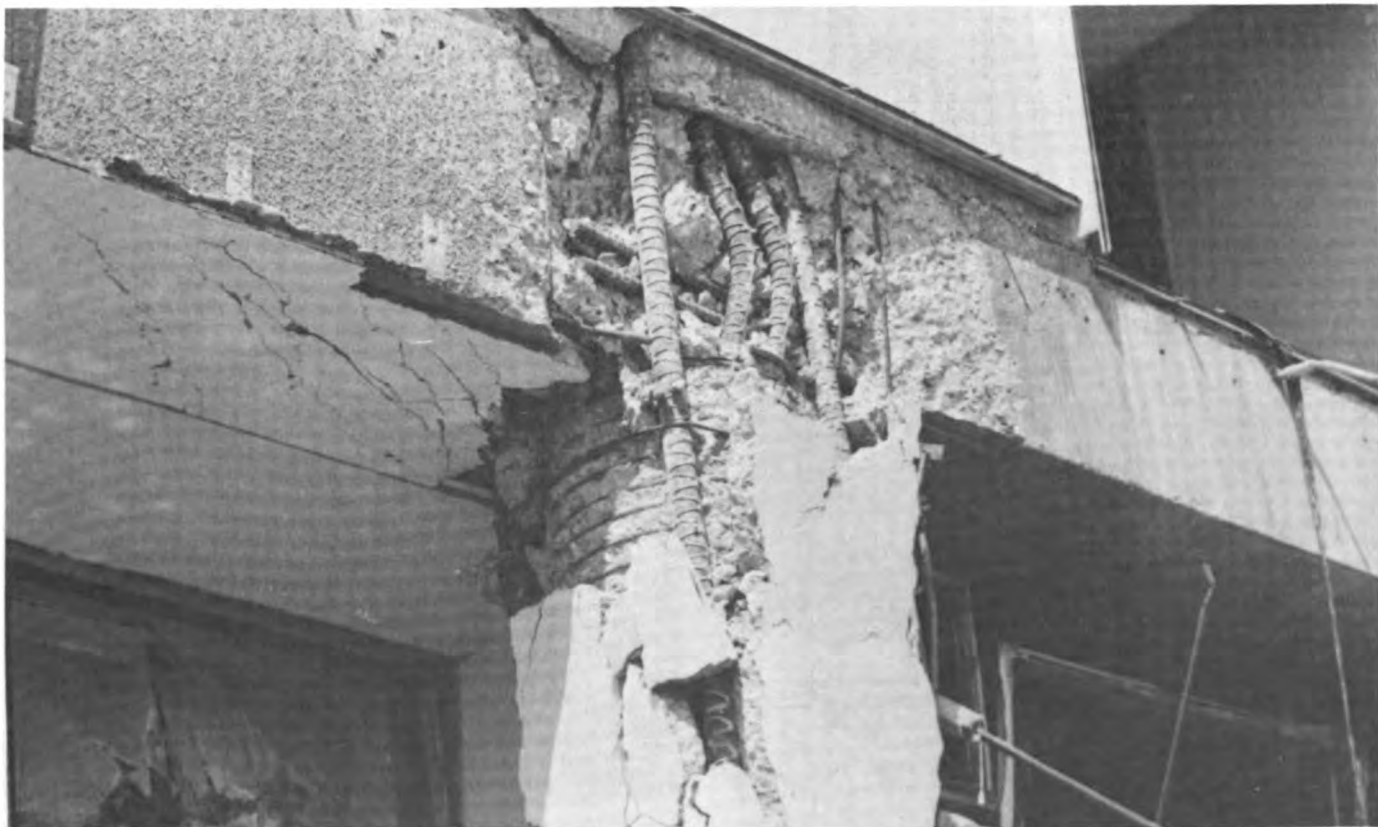
Figure 31.—Olive View Hospital, medical treatment and care unit. Detail view of adjacent column of figure 30, showing distress to connection where confinement was not provided.

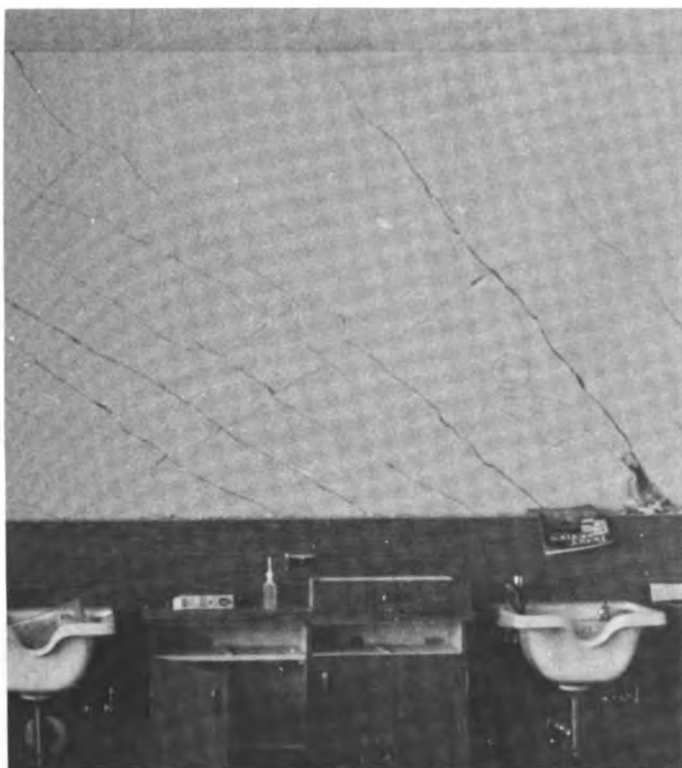
Figure 33.—Olive View Hospital, medical treatment and care unit.  
Diagonal cracks in shear wall at second floor.

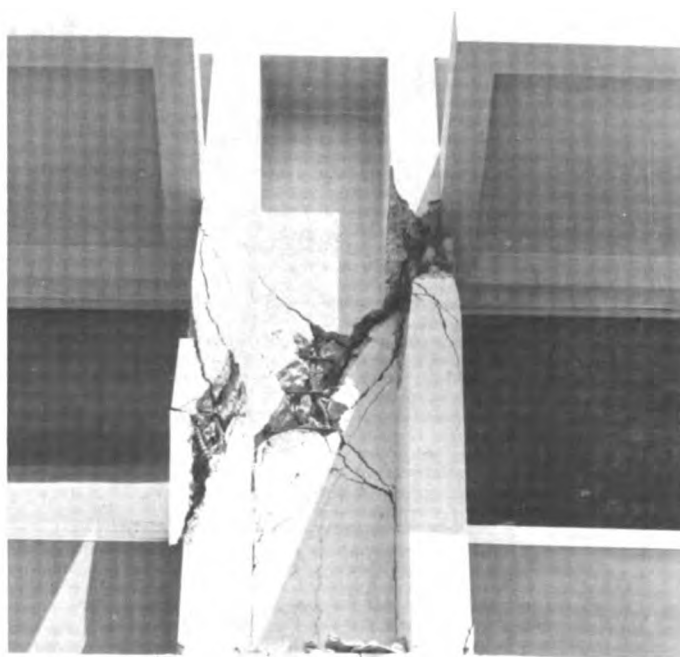
Figure 35.—Olive View Hospital, medical treatment and care unit.  
Diagonal shear cracks in second-floor exterior wall panels viewed from outside.

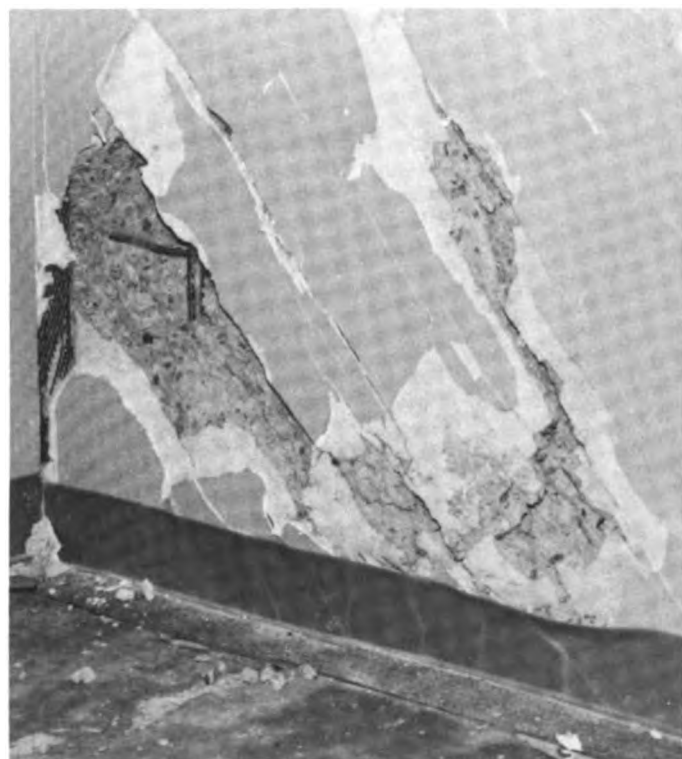
Figure 34.—Olive View Hospital, medical treatment and care unit.  
Diagonal cracks and spalling at floorline at wall shown in figure 33.

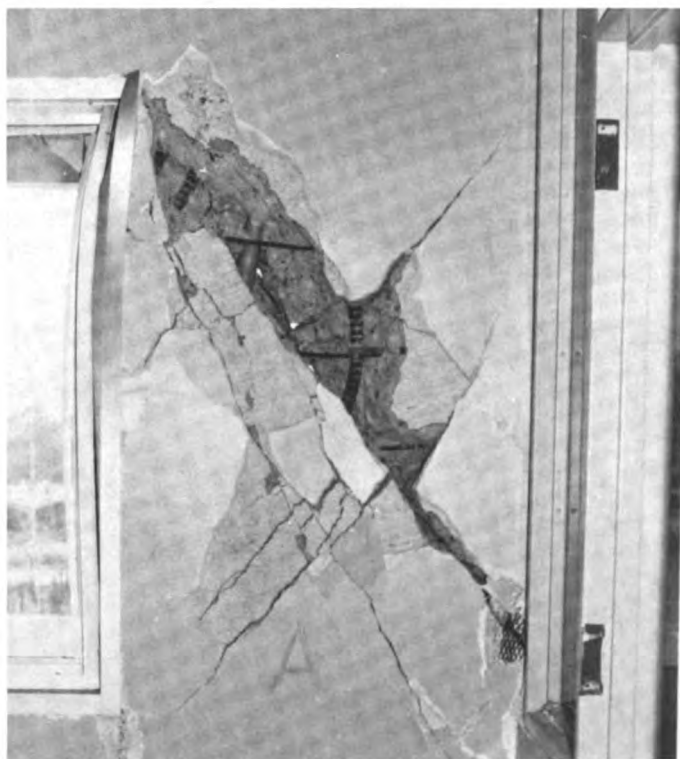
Figure 36.—Olive View Hospital, medical treatment and care unit.  
Diagonal cracks in figure 35 viewed from inside.

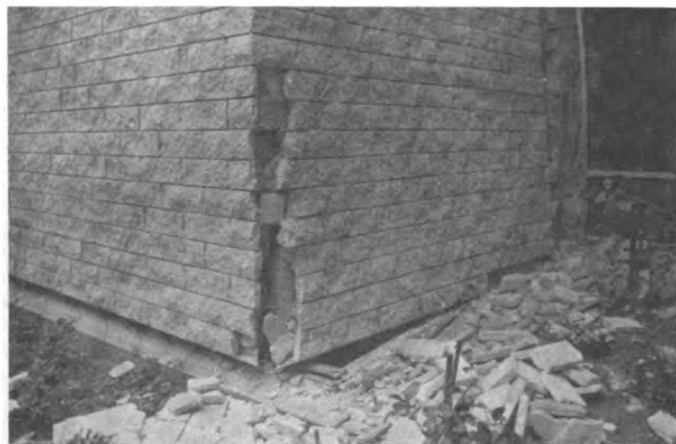
In addition to observed structural damage, there was considerable distress in the nonstructural features. In summary, nonstructural masonry walls were torn loose (figs. 11,B and 37); many precast concrete fascia elements were dislodged (figs. 38 and 39); walls collapsed (fig. 40); connections anchoring the precast concrete failed (figs. 41 and 42); interior partitions, ceilings, and other architectural features were damaged severely (fig. 43); and mechanical and electrical equipment failed to function.

**Figure 37.**—Olive View Hospital, medical treatment and care unit. Shift of southwest corner of east elevator at first-floor level. Wall was designed to be nonparticipating in resisting lateral loads and was separated from floor framing at this level.

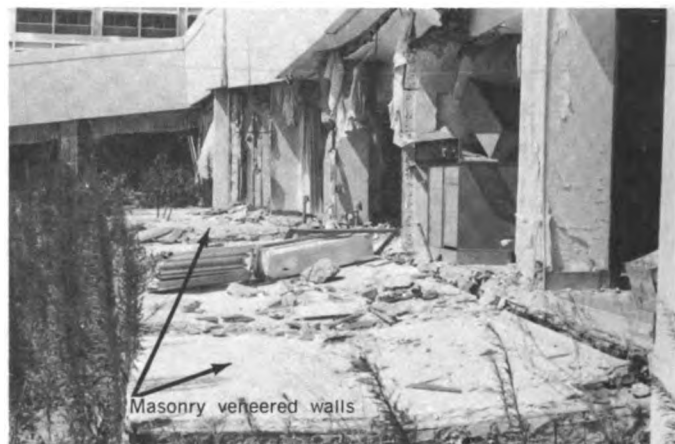
**Figure 40.**—Olive View Hospital, medical treatment and care unit. Masonry veneer walls lying on ground-floor level. These fell away from building due to earthquake movements.

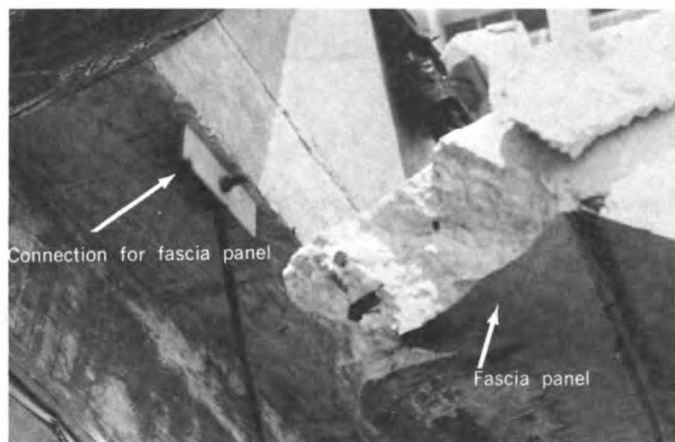
**Figure 38.**—Olive View Hospital, medical treatment and care unit. View from below of precast fascia panel connection to the concrete beams along first floor. View is at southwest corner of building.

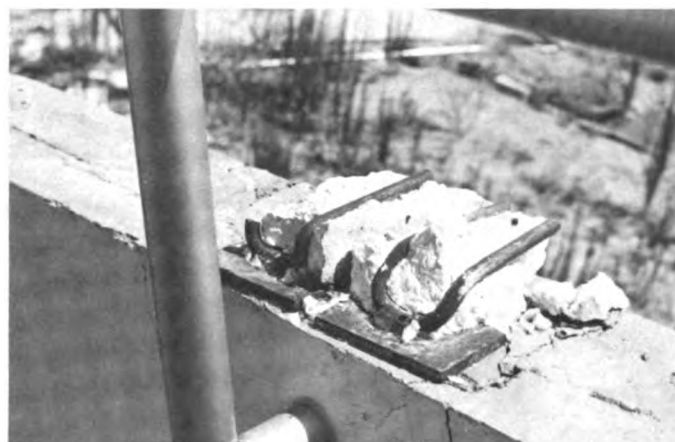
**Figure 41.**—Olive View Hospital, medical treatment and care unit. Upper connection of precast unit in figure 38 where failure occurred in precast unit concrete.

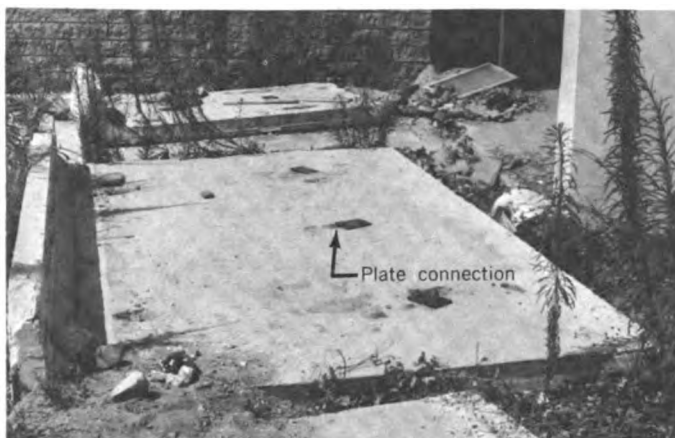
**Figure 39.**—Olive View Hospital, medical treatment and care unit. Precast units lying on ground. These were supported at first-floor level before earthquake.

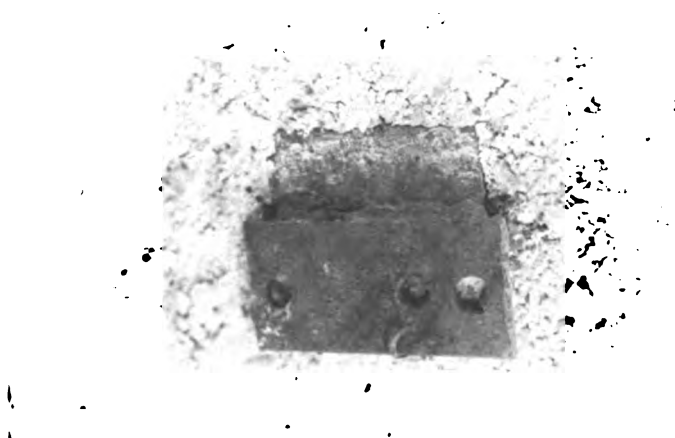
**Figure 42.**—Olive View Hospital, medical treatment and care unit. Lower connection of precast panel. Plate insert cast into panel was welded to stud bolts shown in figure 38.

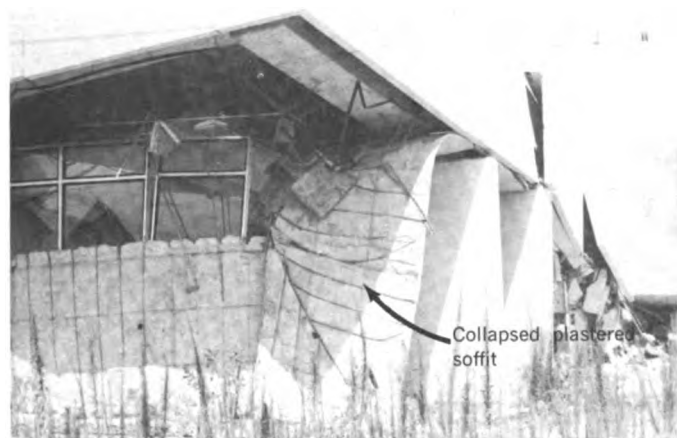
Figure 43.—Olive View Hospital, medical treatment and care unit. Ground-floor level framing at southwest corner which supports first-floor planting on roof. Note loss of plastered soffit and window wall damage from excess movement.

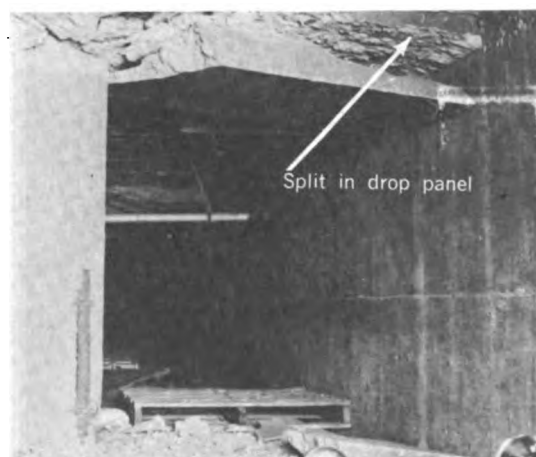
Figure 44.—Olive View Hospital, medical treatment and care unit. Distress to ground-floor flat slab drop panel adjacent to north wall. Some indication of uplift of north stair tower to retaining wall was indicated by splitting of drop panel area.

In the north stair tower, the south wall was anchored into the basement retaining wall (fig. 44), which was pounded by the side lurch of the main structure. Although this pounding contributed to the tilt of the tower (fig. 45), the main cause was the failure of the columns under the north wall (figs. 46, 47, and 48). The bearing of the grade beams and the grade slab against the soil sustained the tower from overturning.

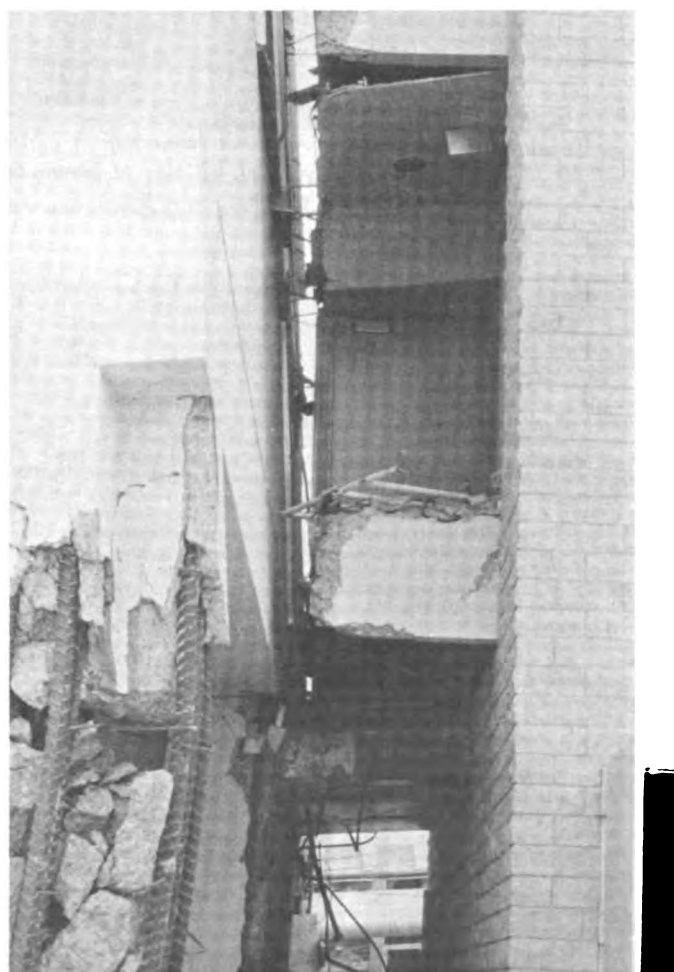
Figure 45.—Olive View Hospital, medical treatment and care unit. Tilt of north stair tower from building viewed from ground-floor level.

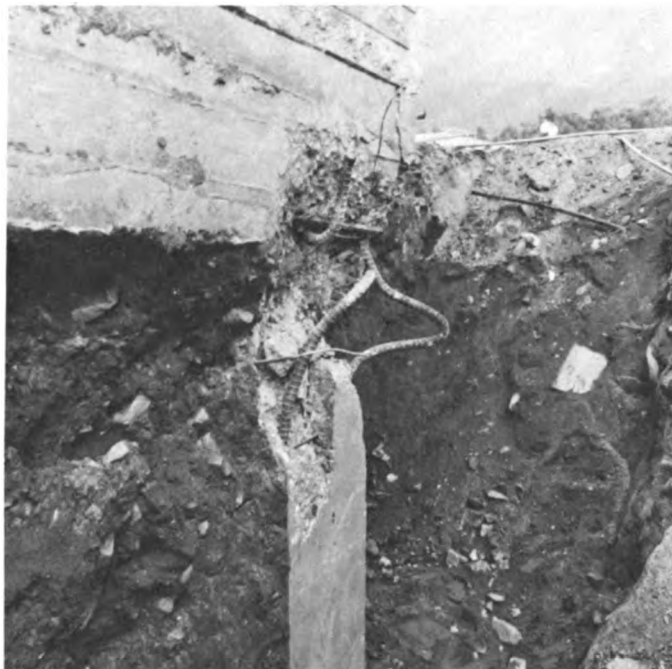
*Figure 46.—Olive View Hospital, medical treatment and care unit. Northwest corner of north stair tower below first-floor ground level. Note complete collapse of tied concrete column below grade beam. LeRoy Crandall & Associates photograph.*

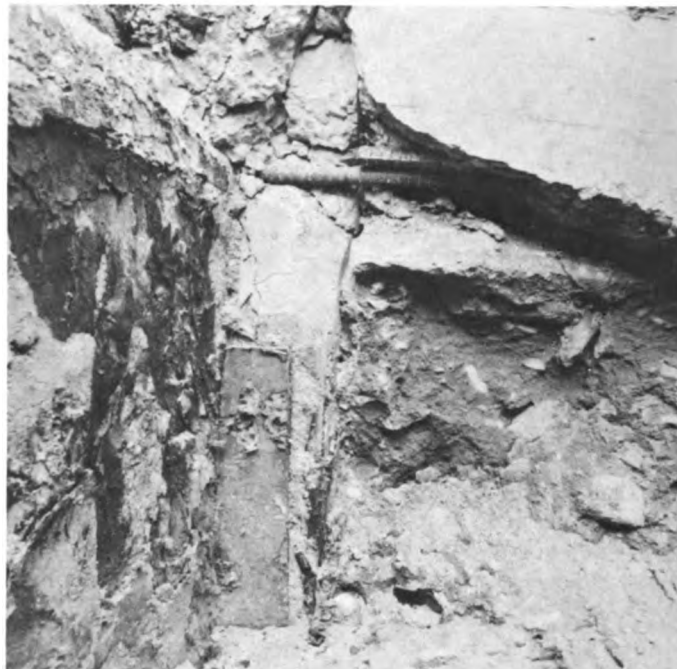
*Figure 48.—Olive View Hospital, medical treatment and care unit. Southeast connection of north stair tower to basement retaining wall at left side of photo. LeRoy Crandall & Associates photograph.*

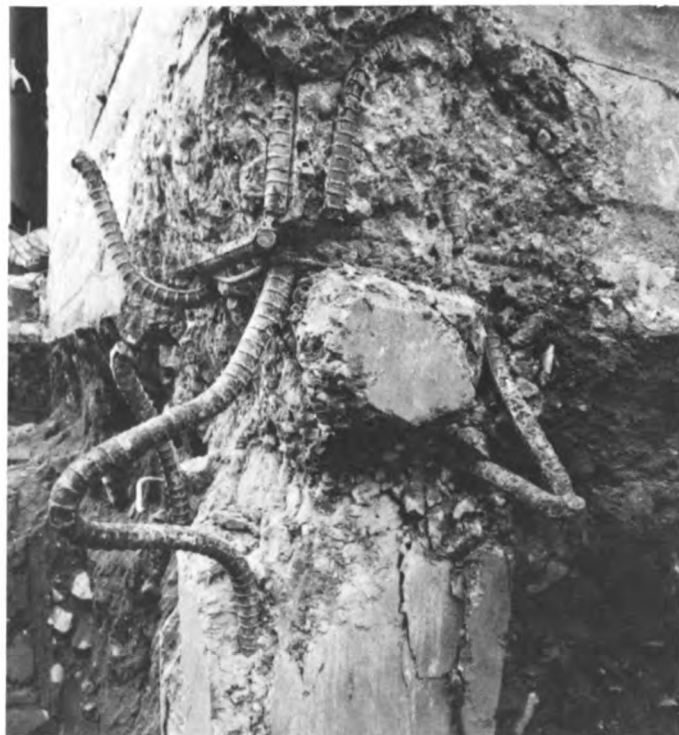
*Figure 47.—Olive View Hospital, medical treatment and care unit. Northeast corner of north stair tower with close view of column collapse. LeRoy Crandall & Associates photograph.*

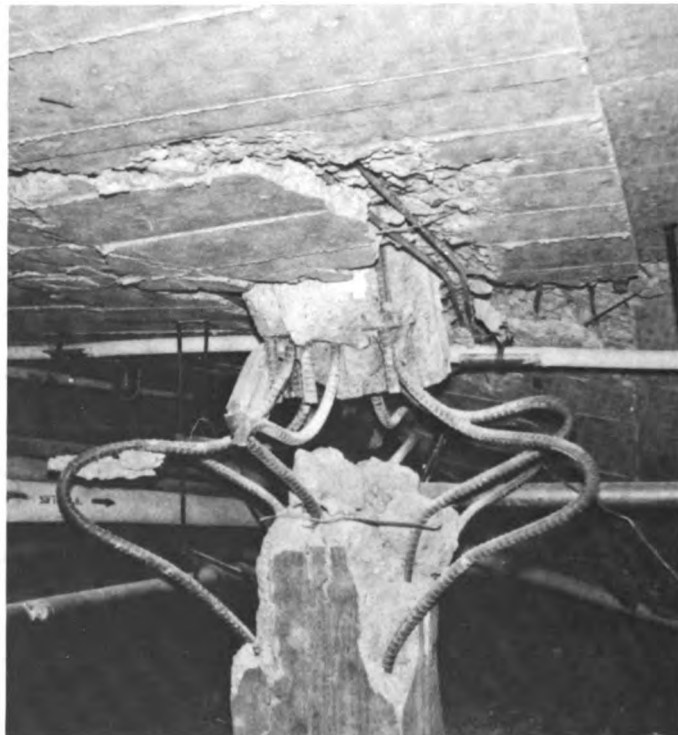
*Figure 49.—Olive View Hospital, medical treatment and care unit. Collapse of southeast column of west stair tower in pipe space below ground floor. Tied column was separated from ground-floor slab in design.*

The other towers overturned because the supporting column and beam structure in the lower story failed, probably in shear. In the west tower the column failed, as observed in the pipe space below the ground-floor level (fig. 49). Inadequate confinement and low shear capacity are evident in this column.

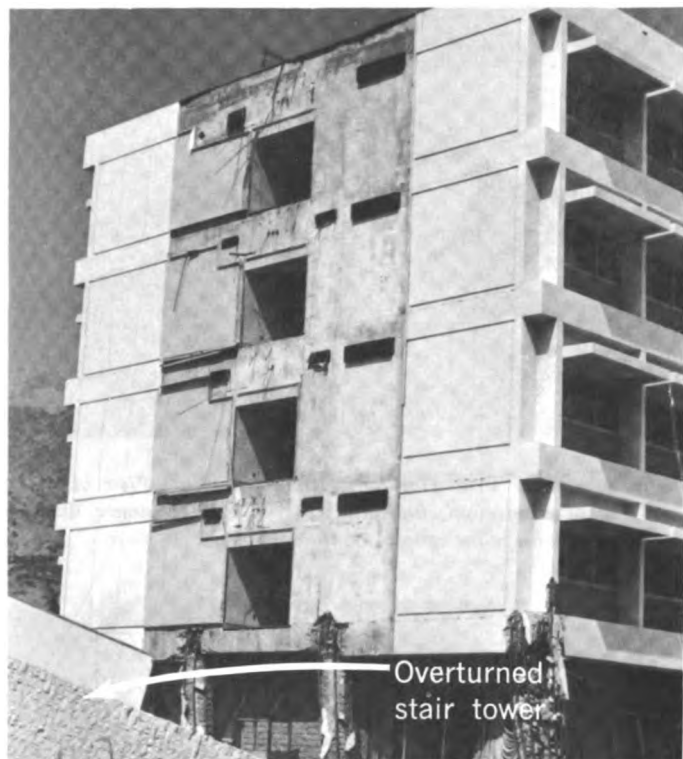
Figure 50.—Olive View Hospital, medical treatment and care unit. South end view of south wing with stair tower in its overturned position.

In the collapsed south tower (figs. 50 and 51), there were other contributing factors. The columns were offset from the corners and interrupted the anchorage of the continuous column steel.

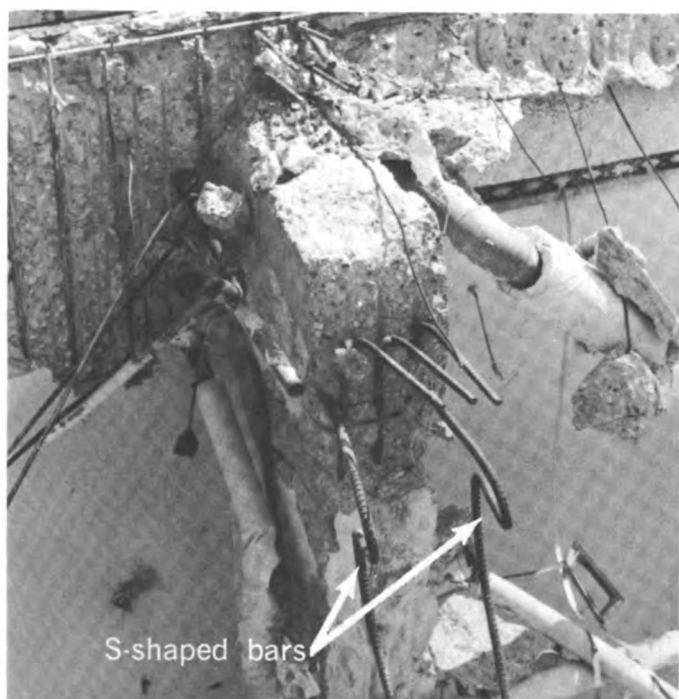
Figure 51.—Olive View Hospital, medical treatment and care unit. Bottom view of south stair tower with first-floor framing shown intact. Note the S-shaped column bars which extended to foundation.

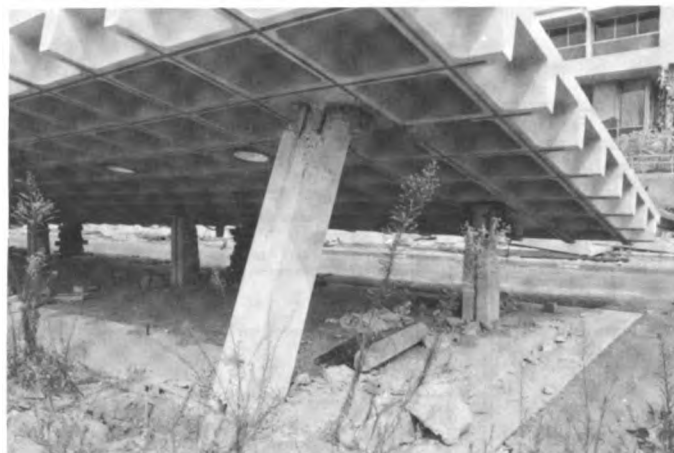
Figure 52.—Olive View Hospital, ambulance canopy. View looking north, showing collapse of north tied columns and subsequent rotation at south column line.

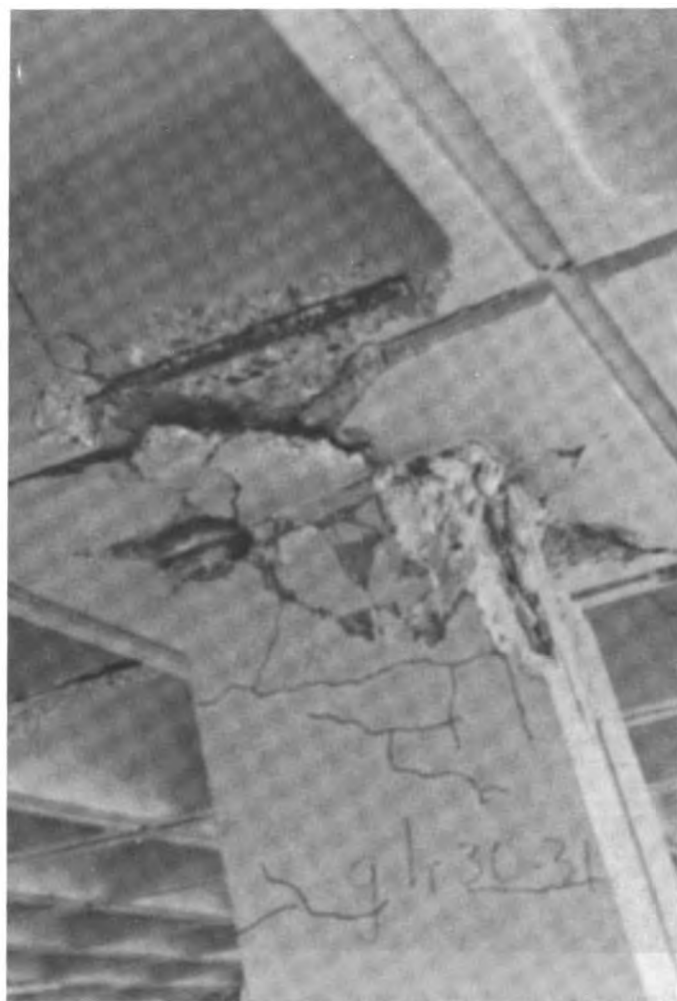
Figure 53.—Olive View Hospital, ambulance canopy. Closeup view of south column upper connection to roof framing.

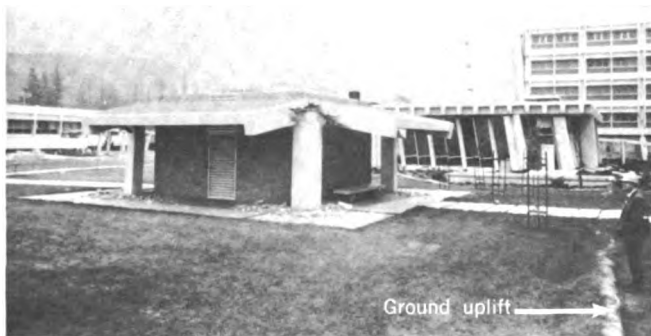
Figure 55.—Olive View Hospital, exhaust building. View looking northeast, with assembly building and north stair tower in background. Note ground uplift (at right of photo) as result of basement wall movement.

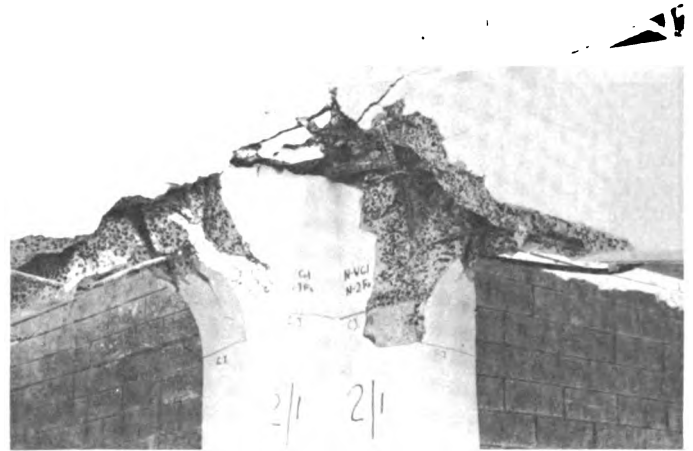
Figure 56.—Olive View Hospital, exhaust building. View of roof-to-column connection, indicating the loss of resistance due to lack of anchorage for column reinforcing bars.

The damage to the structure was primarily in the cantilever girders (figs. 56 and 57) and, particularly, in the beam-column joint. The vertical column steel lacked the proper end anchorage to resist the induced bending moment caused by lateral deformations.

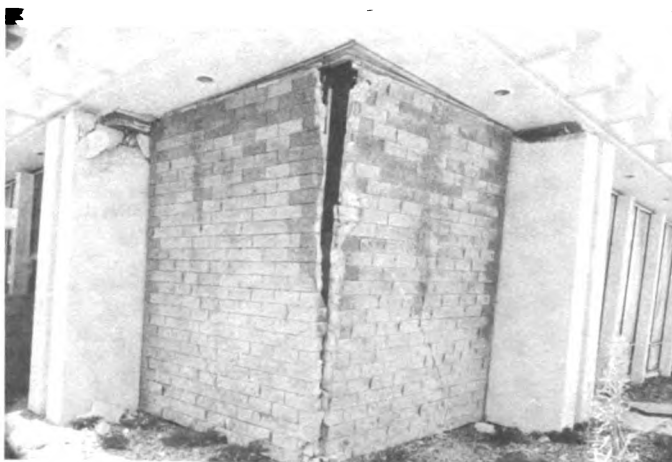
Figure 60.—Olive View Hospital, assembly building. Distortion and cracking of nonbearing masonry walls at northeast corner. Note damage of roof-to-column connection.

The building suffered serious damage. It is evident (fig. 63) that the columns are out of plumb as much as 24 inches. Close examination reveals that the vertical column steel has yielded from severe overstress and taken a permanent set. The window wall sections, the slip joints at the tops of the columns, and many other elements (figs. 60, 61, and 62) could not resist the strain imposed by the large lateral deformation.

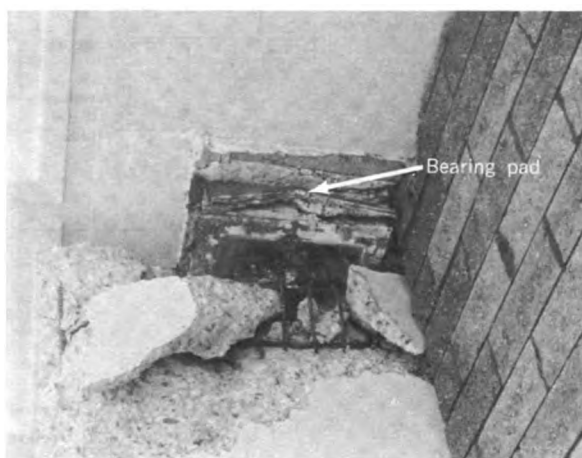
Figure 61.—Olive View Hospital, assembly building. Closeup view of recessed roof connection to column. Note bearing pads.

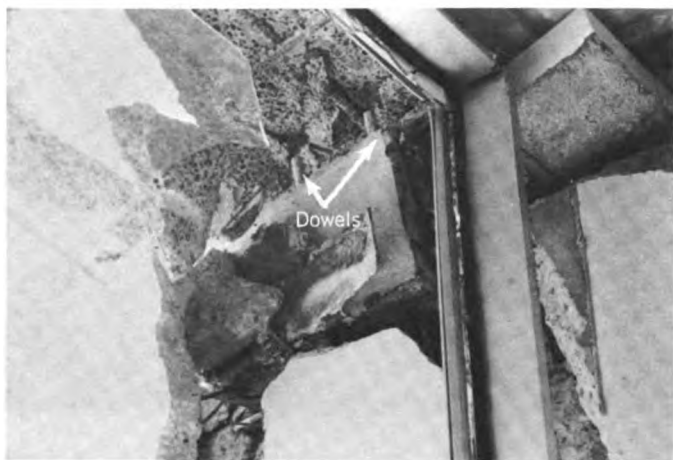
Figure 62.—Olive View Hospital, assembly building. Closeup view of recessed roof connection, showing failure of dowels into roof slab due to lack of anchorage.

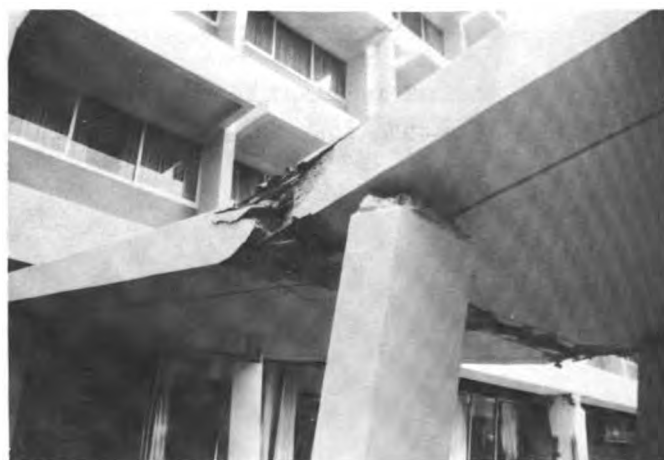
Figure 64.—Olive View Hospital, walkway canopy. View of south end where the cantilevered roof cracked due to movement between medical and psychiatric buildings.

The structure did not collapse fully, but considerable damage resulted from vertical ground deformation of the north ground floor of the medical treatment and care unit. This tilting caused the roof slabs to pull away from the top of the column reinforcing due to lack of anchorage (fig. 64). At the other end of the walkway at the psychiatric unit, the cantilever end of the canopy probably was broken when this building collapsed (figs. 65 and 66).

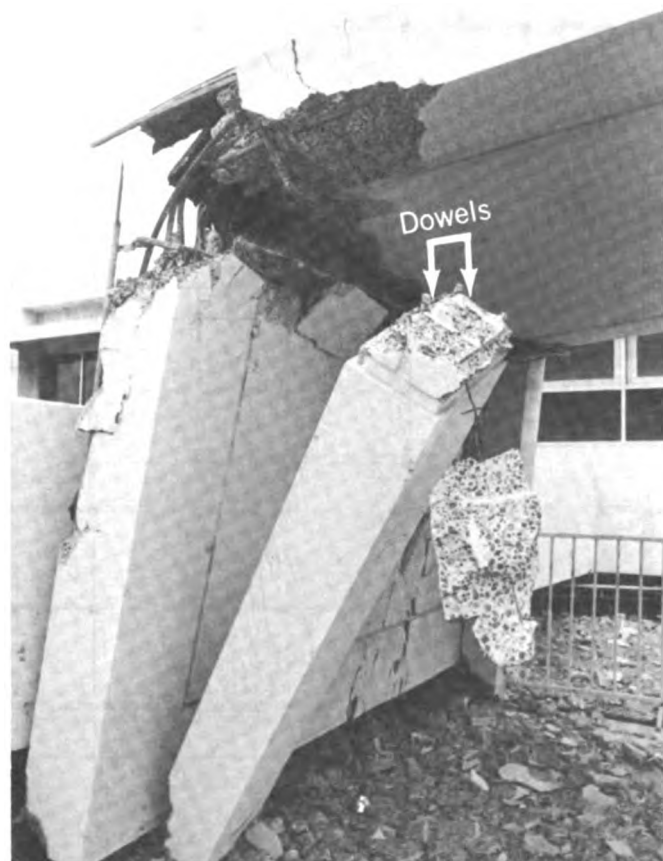
Figure 66.—Olive View Hospital, walkway canopy. Separation of roof slab from top of column. Note lack of anchorage of column bars into slab.

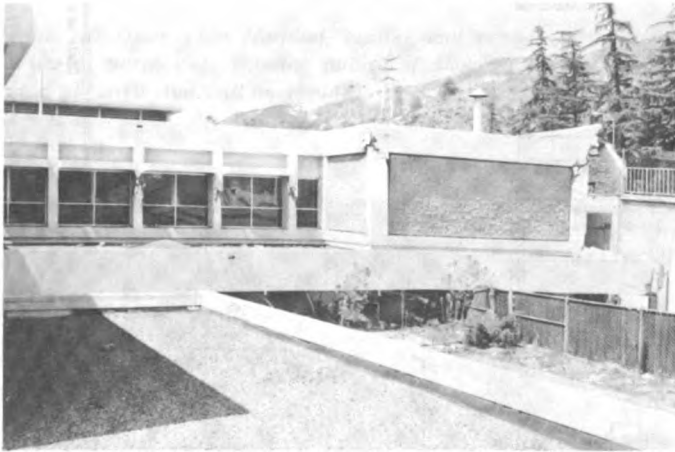
Figure 71.—Olive View Hospital, psychiatric unit. Second-floor view of northeast corner, showing distress to concrete columns and beams around nonshear resisting walls. This building collapsed completely at lower story.

The second-story columns were damaged severely, but did not collapse. The confinement of the masonry walls within the concrete frames appears to have been sufficient to require the walls to act as lateral-resisting elements (figs. 71 and 72). These conditions, and the fact that the yielding first-story columns absorbed much of the energy being transmitted into the structure, appeared to prevent the failure of the second story.

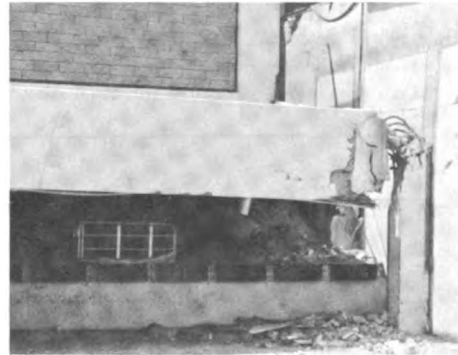
Figure 73.—Olive View Hospital, psychiatric unit. View of northeast corner where the building separated from north retaining wall. Note cracks in wall and position of beam at left relative to its original position next to retaining wall.

The first-story frames failed as a result of column shear failures caused by the large second-floor deflections and resulting high moments (fig. 73). Inadequate column ties to resist the shear forces is probably the major cause of the failures. The ends of the column ties were bent typically through  $135^\circ$ . When the concrete shattered, the ties became disengaged. The participation of the block walls at the first story as lateral-resisting elements was minor, since only a few walls were at this story and many of them had large openings at their ends. The retaining wall added no lateral resistance as the building moved away from it (fig. 74).

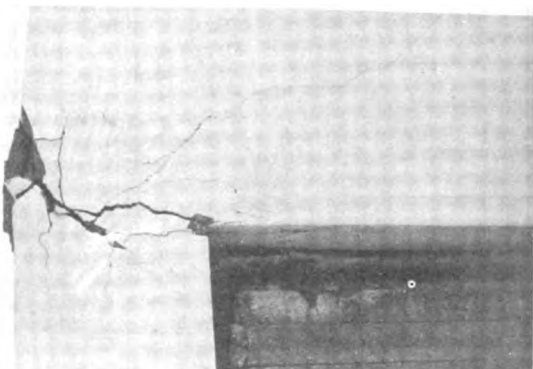
Figure 72.—Olive View Hospital, psychiatric unit. Closeup view of beam-to-column connection.

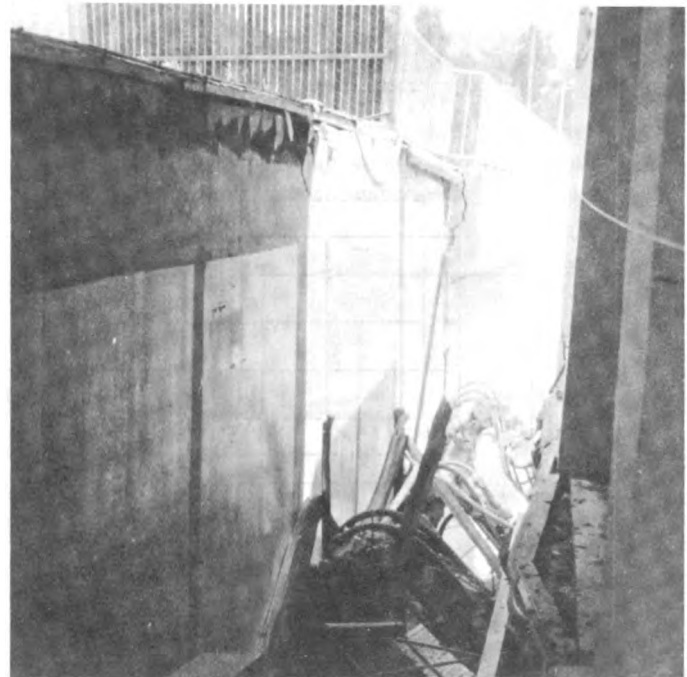
Figure 74.—Olive View Hospital, psychiatric unit. Interior view of north wall, looking east. Floor at right was originally at top of wall.

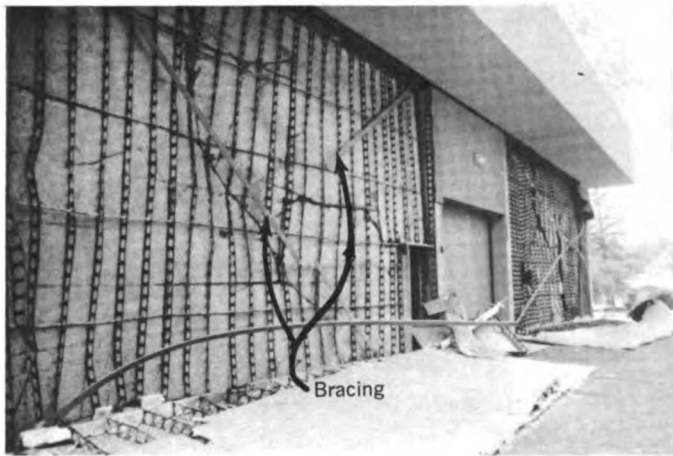
Figure 76.—Olive View Hospital, heating and refrigeration plant. View of north wall, showing failure of diagonal bracing straps and plastered stud wall on ground.

Damage to the building started with the diagonal straps in the north wall, stretching well into the yield range. The elongated straps permitted a large deformation to occur in the building before the straps became effective in resisting further motions (figs. 76 and 77). With the bracing ineffective, high torsional loads, in addition to direct lateral loads, were induced into the roof decking and side shear walls.

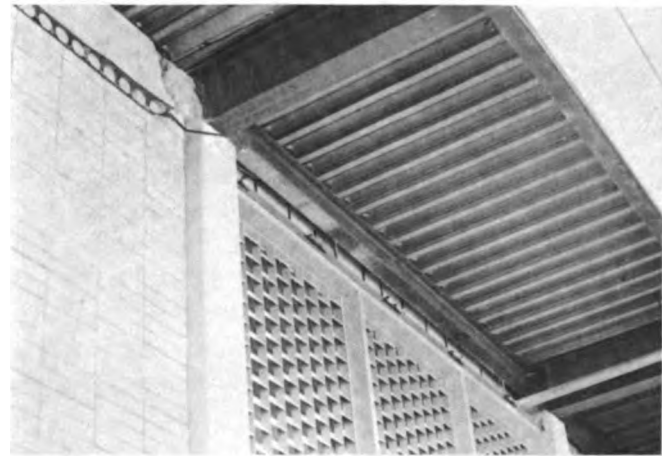
Figure 78.—Olive View Hospital, heating and refrigeration plant. Distress to upper column connection of beam and wall on east side. Note loss of ceiling below roof deck.

The high lateral loads and induced torsion caused strut loads at the east and west sides that, according to calculations, exceeded the design loads by 250 percent. These strut loads were carried by steel beams to anchors embedded in the top of the east and west block walls (figs. 78 through 80). The cracks in the wall resulting from the high strut loads are shown in figure 81. There was some uplift at the columns at the ends of these block walls, but this force did not appear to be excessive.

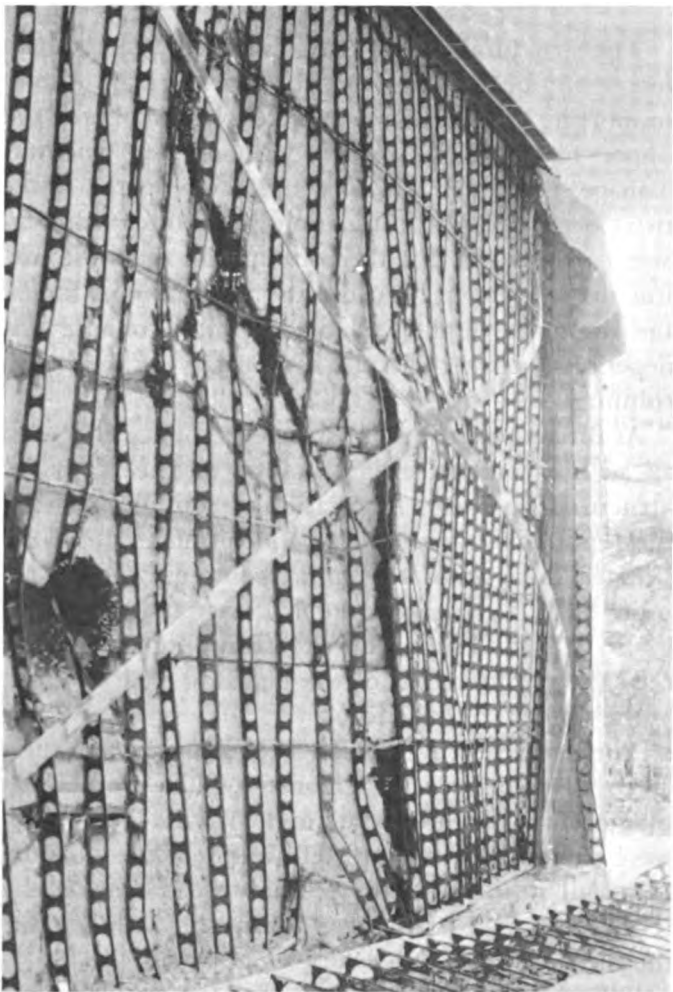
Figure 77.—Olive View Hospital, heating and refrigeration plant. Excessive deformation of diagonal bracing shown in figure 76. Vertical crack in plaster wall was caused by shifting of equipment within the building, as seen in figure 84.

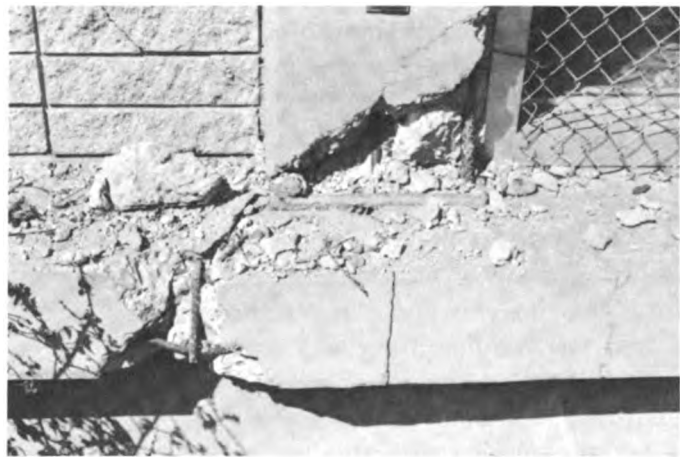
Figure 79.—Olive View Hospital, heating and refrigeration plant. Distress to lower column connection of figure 78.

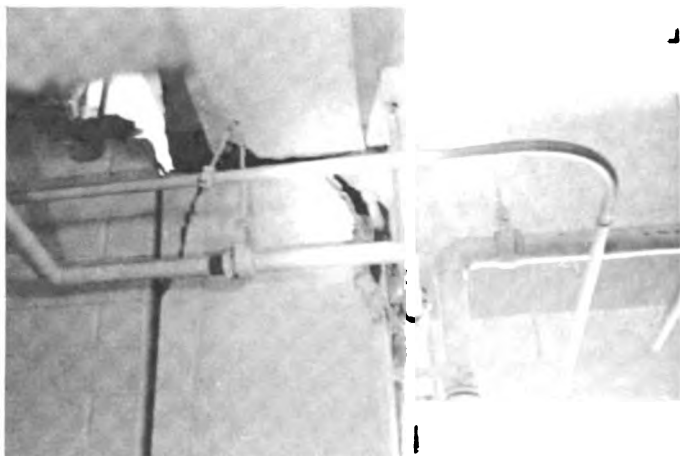
Figure 80.—Olive View Hospital, heating and refrigeration plant. Distress to upper column connection at west side.

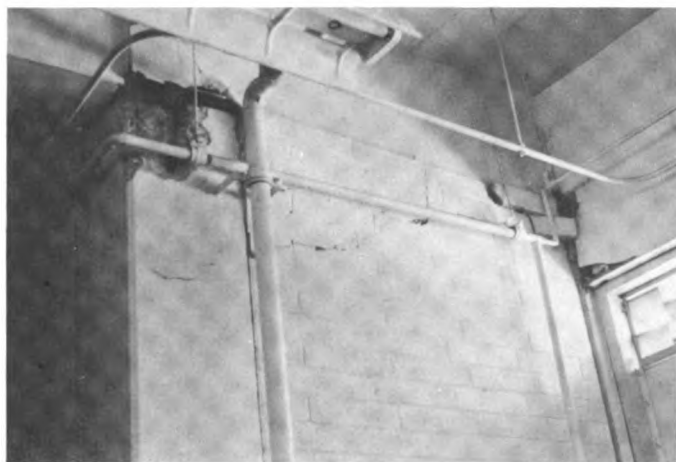
Figure 81.—Olive View Hospital, heating and refrigeration plant. Cracking in masonry wall and concrete column at west side of column shown in figure 80.

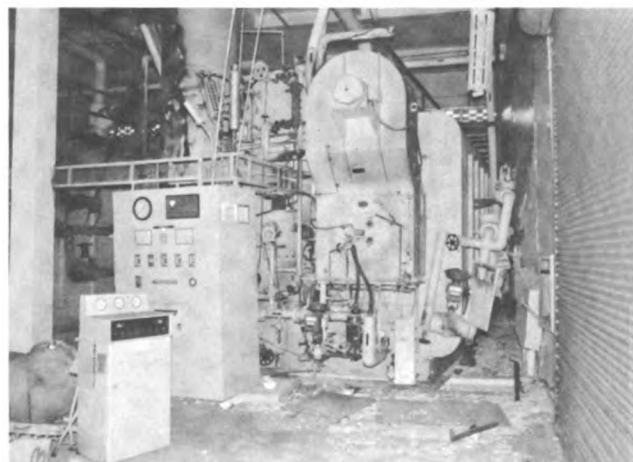
Figure 84.—Olive View Hospital, heating and refrigeration plant. Boiler final location against north wall.

Another area of damage of major proportions involved many heavy pieces of inadequately anchored equipment, which moved along the floor. In some cases, this movement produced damage to walls or piping (figs. 83 and 84).

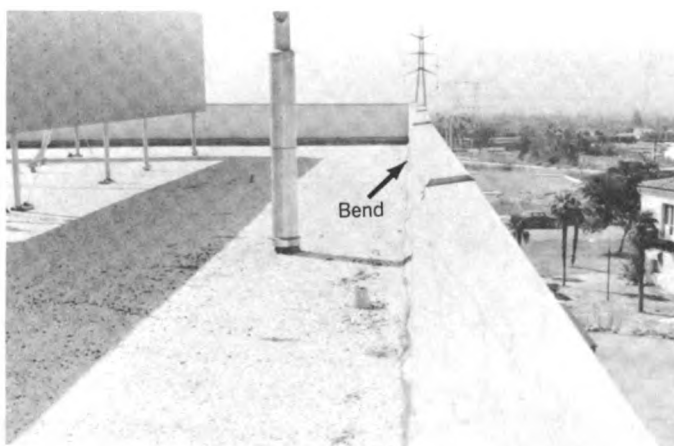
Figure 82.—Olive View Hospital, heating and refrigeration plant. Distortion of west parapet.

In figure 82, some buckling can be seen to have occurred at the west parapet. It also was observed that diagonal stress patterns occurred in the roof at the west side which indicates probable buckling in the steel decking under the roofing material.

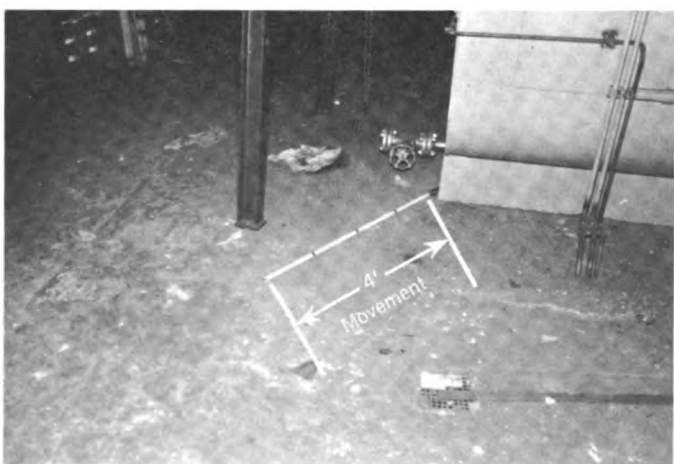
Figure 83.—Olive View Hospital, heating and refrigeration plant. Final location of boiler on floor near west wall. Total movement was about 4 feet.

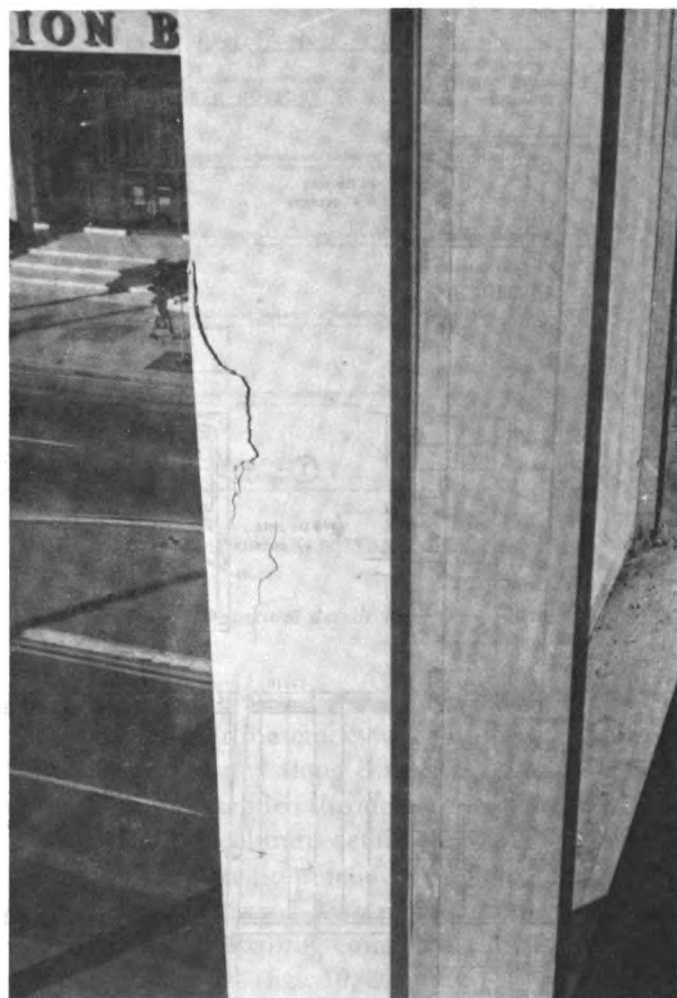
Generally, visible structural damage was slight and consisted almost entirely of minor cracking and spalling of concrete (figs. 10 and 11). However, in some areas, extensive cracking occurred, particularly at the exposed girder stubs at the exterior columns along the second-floor level (figs. 12 and 13).

Figure 11.—Bank of California. Spalling of concrete at northwest corner column, fourth floor. This condition, which did not occur at any other location, may have resulted from a defective concrete patch during construction. Brandow & Johnston photograph.

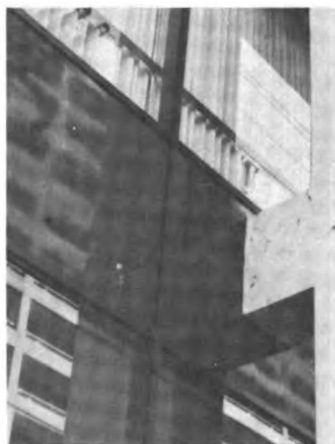
At the second floor, girders projecting beyond the spandrel line were damaged. The parapet on the one-story low roof structure attached to the main building also was damaged. The torsion induced in girder stubs projecting from columns on the north and south sides caused cracking as shown in figures 12 and 13. The stubs are located at alternate columns, except at corners, and for the north and south sides were not considered seismic force-resisting elements. Girder stubs on the west side also showed some bending cracks.

Figure 12.—Bank of California. Exterior second-floor girder-column joint in nonseismic north-south frame. Note that spandrel beam, which lies hidden behind curtain wall, is considerably offset from column centerline. John A. Blume & Associates photograph.

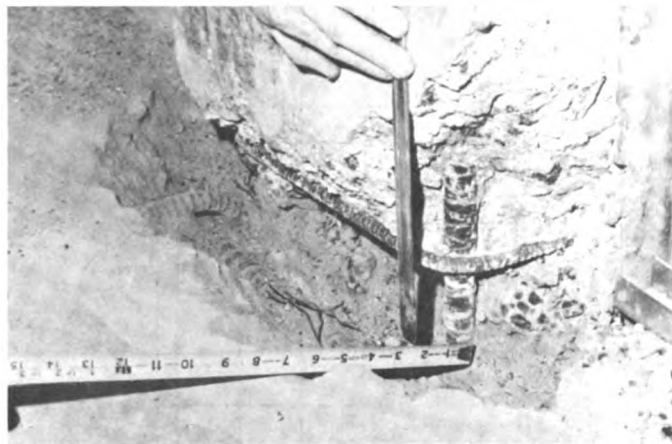
At floor level on the third, fourth, and fifth floors, exterior columns typically spalled (figs. 14 and 15). On the east and west sides of the building, spalling also occurred at the top of the columns, but only on the interior column face. On the east and west sides, some spandrels showed areas of spalling near the columns.

Figure 15.—Bank of California. Detail of spalled and chipped area similar to that shown in figure 14. Note that top joist reinforcement was terminated by hooks at column face and was not extended into confined area of column. Brandow & Johnston photograph.
